Assessing leachate contamination and groundwater vulnerability in urban dumpsites: a case study of the Ipata Area, Ilorin, Nigeria

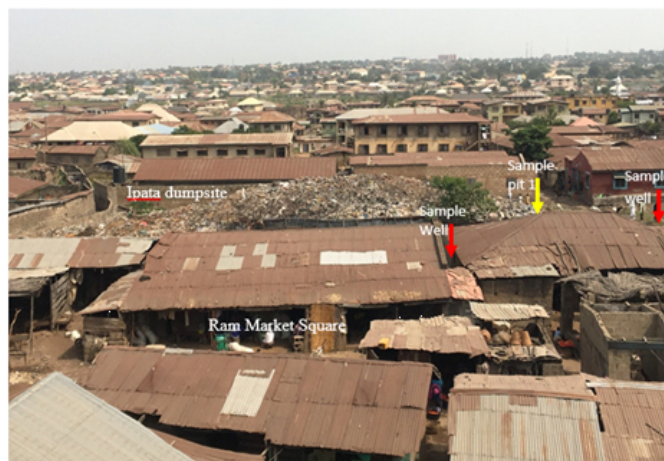
Figure 1. Aerial View of Ipata area showing the Open Dumpsite, a sample pit position, and some sample hand-dug wells.

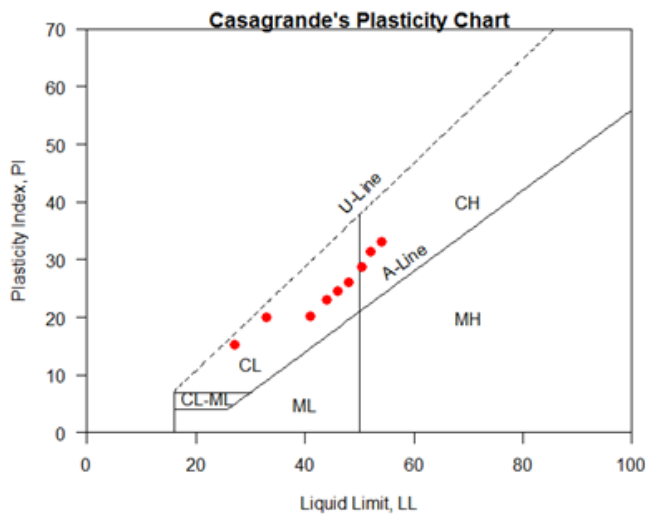
Figure 6. Plasticity Chart for the soil samples: CL-inorganic clays of low plasticity (impervious); ML-inorganic silt of low plasticity (impervious); and CH-inorganic clays of high plasticity.

to 65%, highest at greater depths Figure 6. The fines content exceeds the recommended $\geq 50\%$ for clay liner materials, indicating unsuitability for preventing leachate percolation near the surface but effectiveness at deeper depths. Liquid limits ranged from 18.92% (pit 1) to 54% (pit 3), generally suitable for low hydraulic conductivity and leachate prevention. However, pit 1 fell slightly below the 20% recommended for liner materials, indicating limitations near the surface. The recommended maximum coefficient of permeability value is 1.0×10^{-7} cm/s for landfill barrier soil sets a crucial standard for assessing the suitability of soils to prevent leachate migration in a landfill setting. From the permeability data obtained in pits 2, 3, and 4, it is evident that these locations exhibit varying degrees of permeability, which has significant implications for their effectiveness as barrier materials in landfill construction. In pit 2, the permeability values range between 3.34×10^{-5} cm/s, 3.23×10^{-5} cm/s, and 3.13×10^{-5} cm/s for samples 1, 2, and 3, respectively. These values, while higher than the recommended threshold, are still within the category of low permeability. This suggests that the soils in pit 2 possess some capacity to impede leachate migration but may not provide an ideal barrier against it. Therefore, the suitability of these soils as barrier materials is

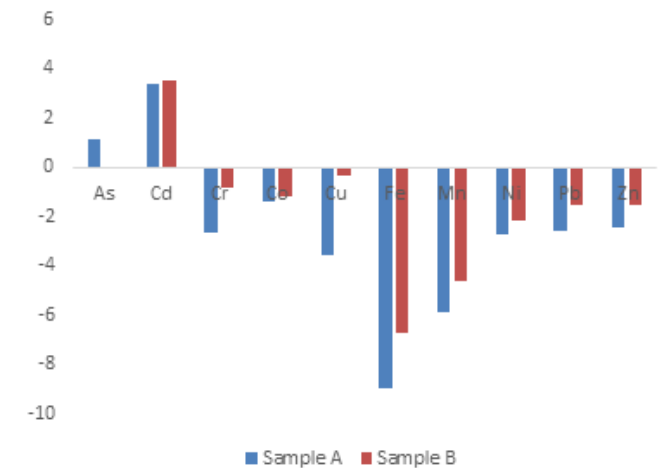
Figure 7. Geochemical analysis results, showing I_{geo} in both samples.

In Figure 7, Cadmium (Cd) exhibited the highest I_{geo} values in both samples (3.36 and 3.56), while Iron (Fe) had the lowest (-8.97 and -6.70). The elevated I_{geo} values for Cd in the soil sample from Ipata market indicate significant soil pollution with Cd, primarily due to anthropogenic activities. These findings align with previous studies by Ohiagu *et al.* and Sulaiman *et al.* [35, 42, 43]. Cd also displayed the highest Contamination Factor (CF) values for both samples, while Fe had the lowest CF values. Besides Cd and As, all other metals studied showed minimal contamination at the site. Pollution Load Index (PLI) values of 0.18 and 0.43, both below 1, classify the site as uncontaminated Table 3. These results concur with Alahabadi & Malvandi [36]. The potential ecological risk posed by the studied metals was assessed using Enrichment (E) and Risk Index (RI). All measured metals, except Cd, showed low ecological risk in both samples. Cd, on the other hand, posed a very high ecological risk, resulting in a high potential ecological risk index for both samples Table 4. This aligns with findings from [36, 44]. Two polycyclic aromatic hydrocarbon compounds (from topsoil and leachate) were identified, accounting for 100% of the composition. They were identified as Stigmast-4-en-3-one (74.99%) and 9,19-Cyclolanostan-3-ol, acetate, (3.β)- (25.01%) and Phenol, 3,5-bis(1,1-dimethylethyl)- (87.07%) and 1,2-Benzenedicarboxylic acid, 2-butoxyethyl butyl ester (12.93%) Figures 8 a-b.
